Spring 2012 CCTV Video Inspection of selected sanitary sewer lines

**Clarke St., Narragansett Ave., Wollcott St.,
Hamilton Ave., Cananicus Ave. & Bay View Drive.**

Infrastructure Technologies Data Generated CCTV Video Inspection Report (PACP Certified)

**Town of Jamestown, WWTP
93 Narragansett Avenue Jamestown, RI 02835**

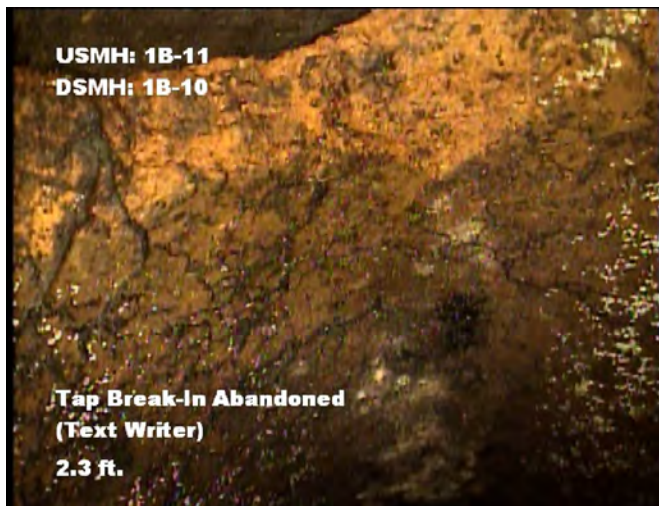
Distance: 2.3 ft. Grade: 0
Condition: Tap Break-In Abandoned
Remarks: N/A

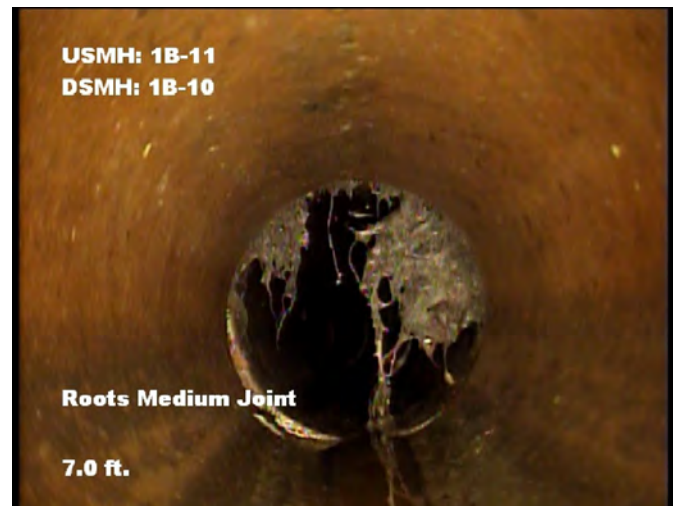
Distance: 7.0 ft. Grade: 3
Condition: Roots Medium Joint
Remarks: N/A

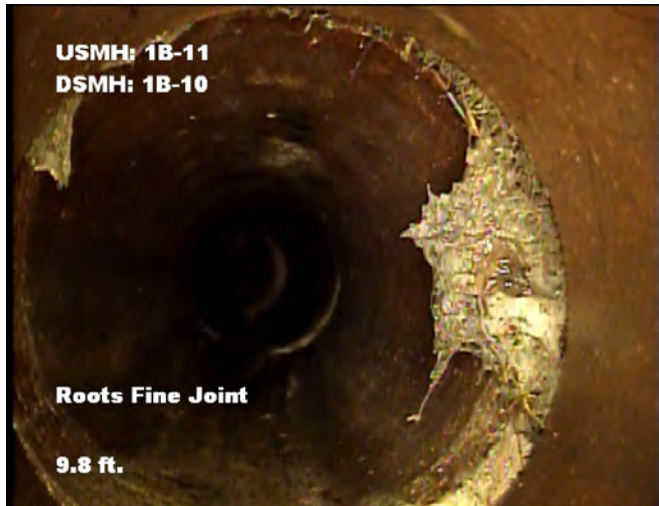
Distance: 9.8 ft. Grade: 1
Condition: Roots Fine Joint
Remarks: N/A

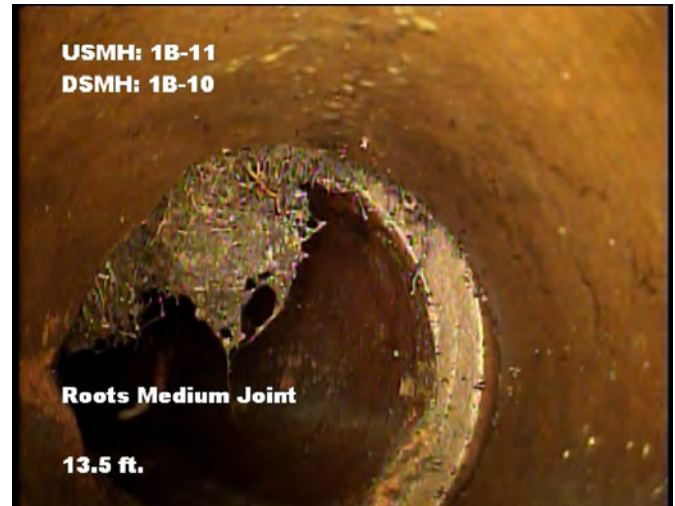
Distance: 13.5 ft. Grade: 3
Condition: Roots Medium Joint
Remarks: N/A

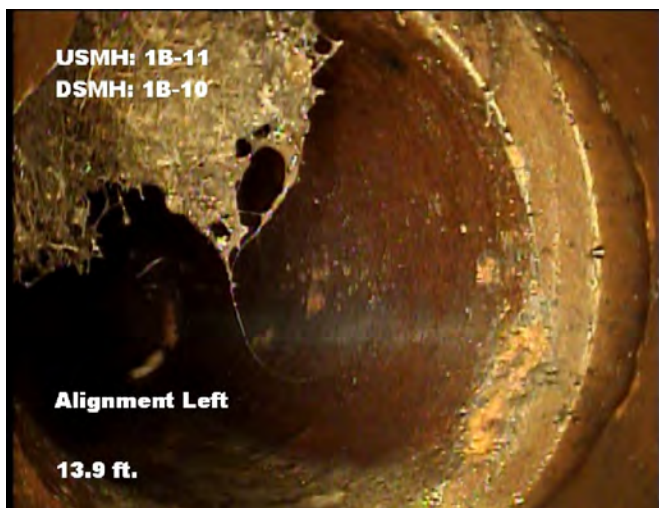
Distance: 13.9 ft. Grade: 4
Condition: Alignment Left
Remarks: N/A

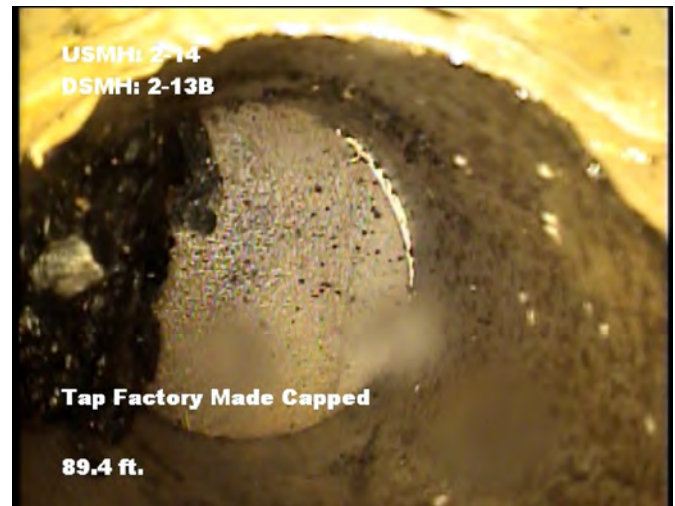
Distance: 89.4 ft. Grade: 0
Condition: Tap Factory Made Capped
Remarks: N/A

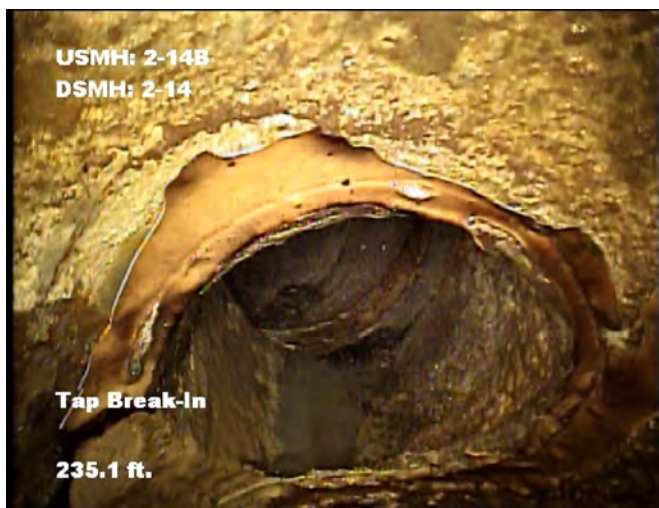
Distance: 235.1 ft. Grade: 0
Condition: Tap Break-In
Remarks: N/A

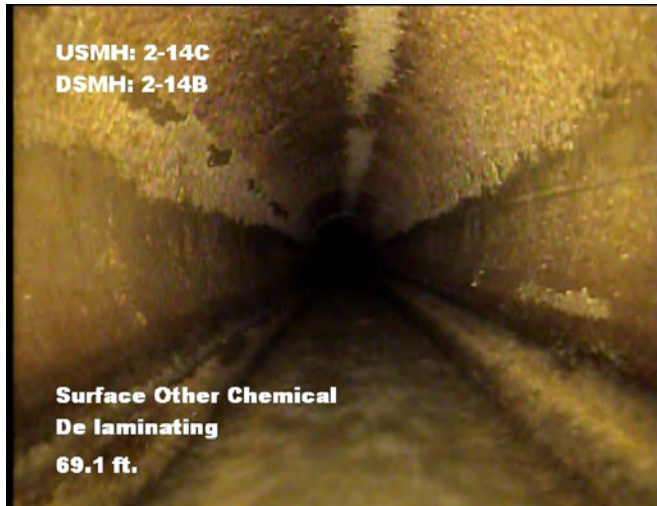
Distance: 68.8 ft. Grade: 0
Condition: Surface Other Chemical
Remarks: De laminating

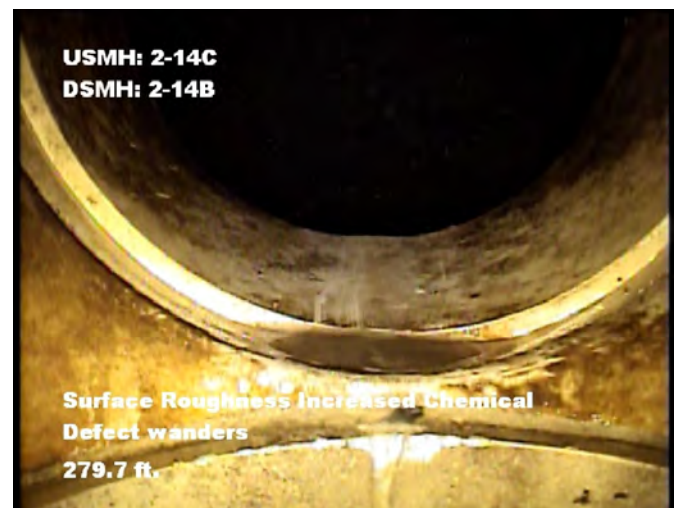
Distance: 279.7 ft. Grade: 1
Condition: Surface Roughness Increased Chemical
Remarks: Defect wanders

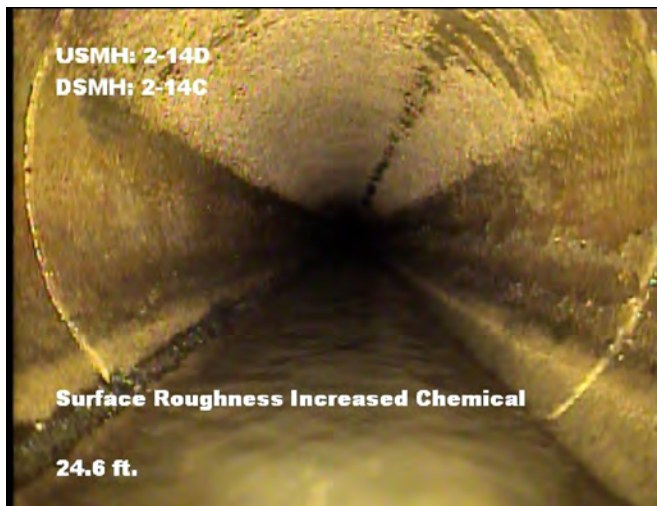
Distance: 24.6 ft. Grade: 1
Condition: Surface Roughness Increased Chemical
Remarks: N/A

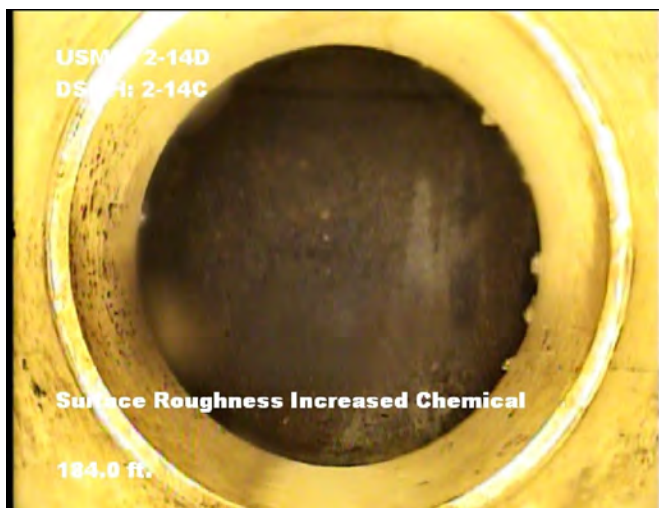
Distance: 184.0 ft. Grade: 1
Condition: Surface Roughness Increased Chemical
Remarks: N/A

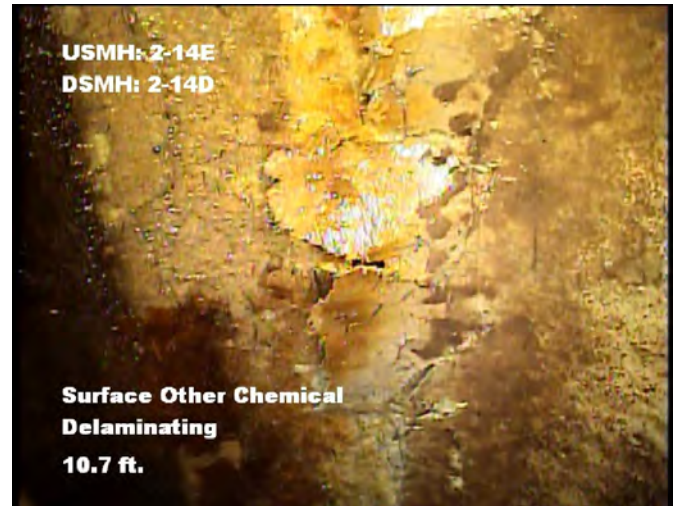
Distance: 10.7 ft. Grade: 0
Condition: Surface Other Chemical
Remarks: Delaminating

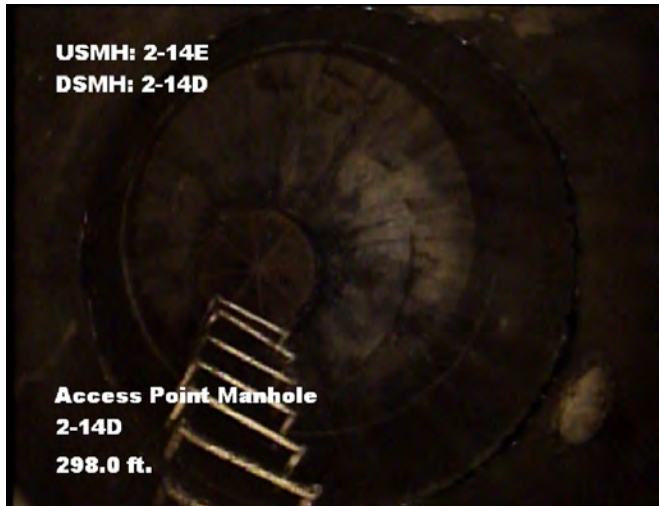
Distance: 298.0 ft. Grade: 0
Condition: Access Point Manhole
Remarks: 2-14D

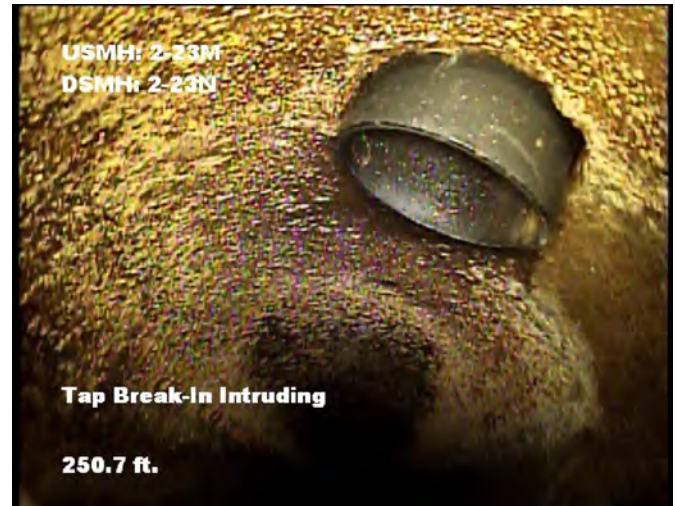
Distance: 250.7 ft. Grade: 2
Condition: Tap Break-In Intruding
Remarks: N/A

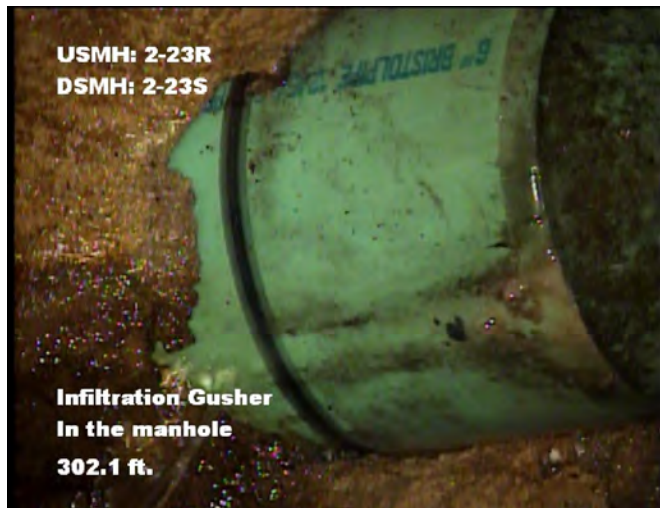
302.1 ft. Infiltration Gusher

Distance: 302.1 ft. Grade: 5
Condition: Infiltration Gusher
Remarks: In the manhole

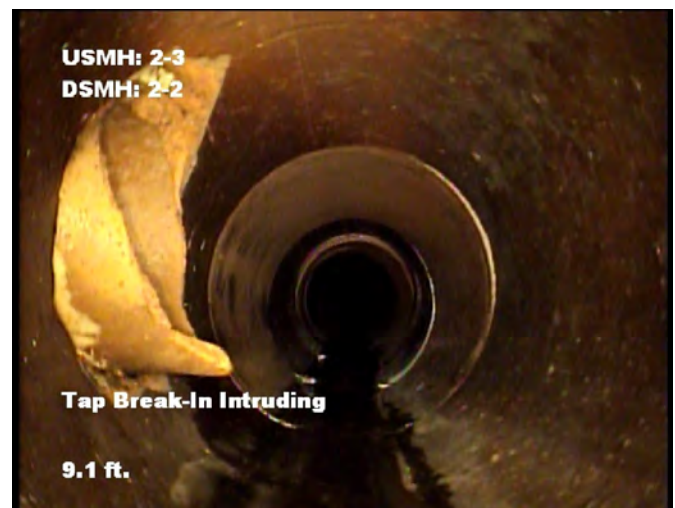
Distance: 9.1 ft. Grade: 2
Condition: Tap Break-In Intruding
Remarks: N/A

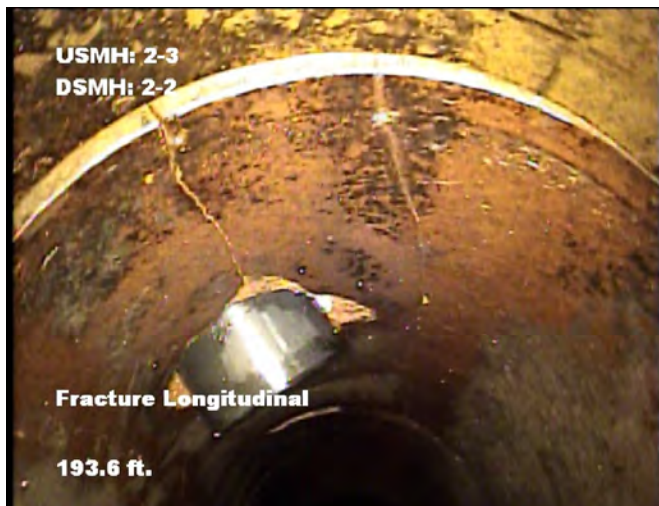
193.6 ft. Fracture Longitudinal

Distance: 193.6 ft. Grade: 3
Condition: Fracture Longitudinal
Remarks: N/A

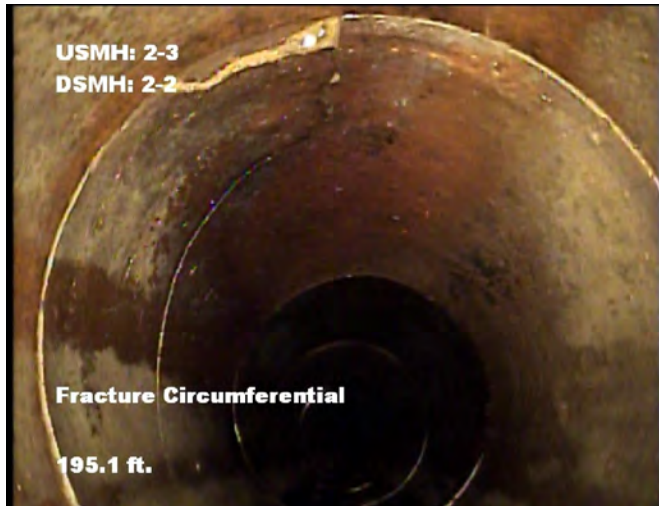
195.1 ft. Fracture Circumferential

Distance: 195.1 ft. Grade: 2
Condition: Fracture Circumferential
Remarks: N/A

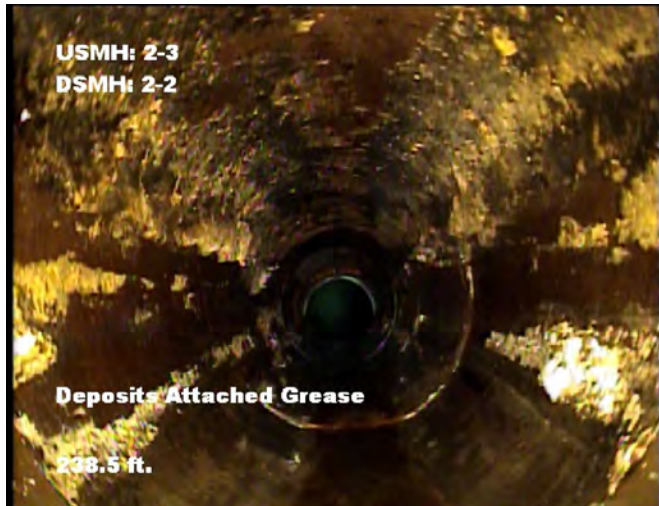
Distance: 238.5 ft. Grade: 2
Condition: Deposits Attached Grease
Remarks: N/A

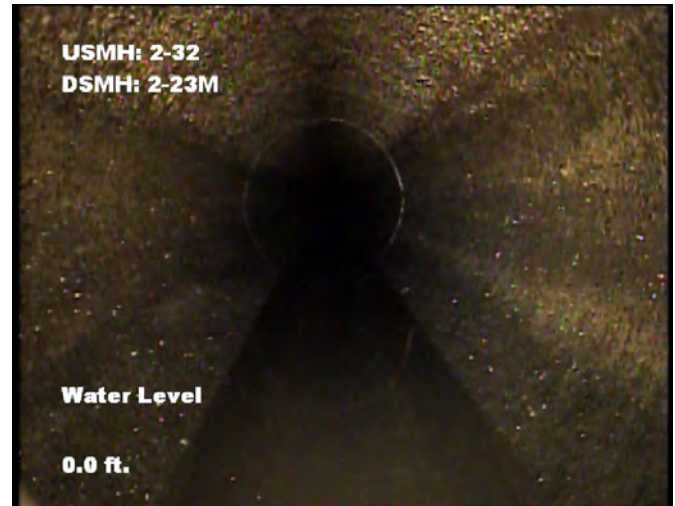
Distance: 0.0 ft. Grade: 0
Condition: Water Level
Remarks: N/A

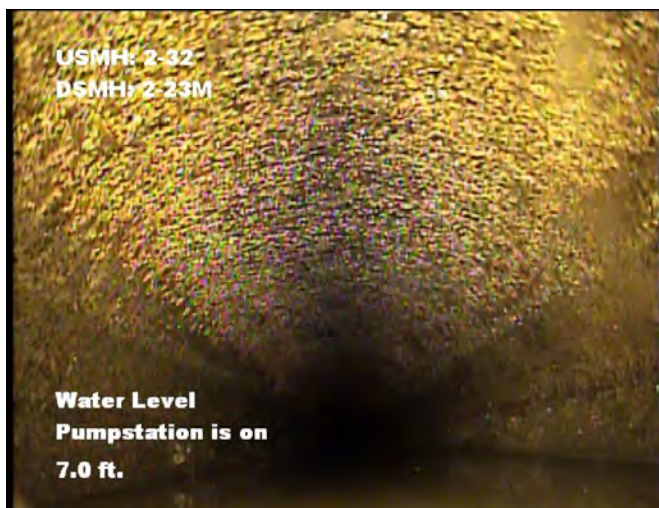
Distance: 7.0 ft. Grade: 0
Condition: Water Level
Remarks: Pumpstation is on

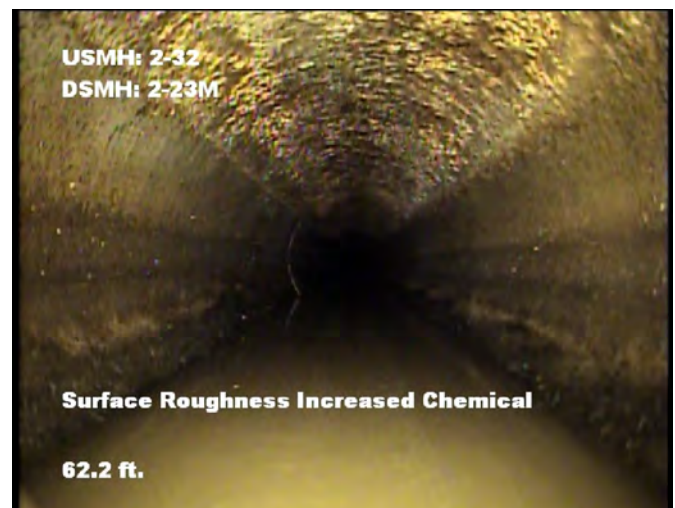
Distance: 62.2 ft. Grade: 1
Condition: Surface Roughness Increased Chemical
Remarks: N/A

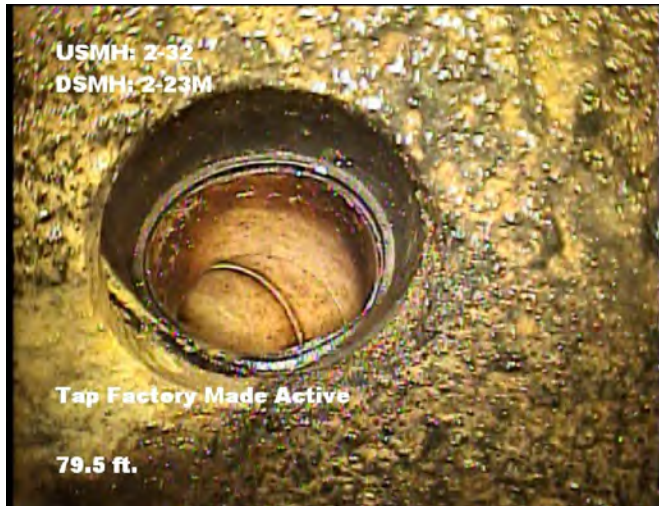
Distance: 79.5 ft. Grade: 0
Condition: Tap Factory Made Active
Remarks: N/A

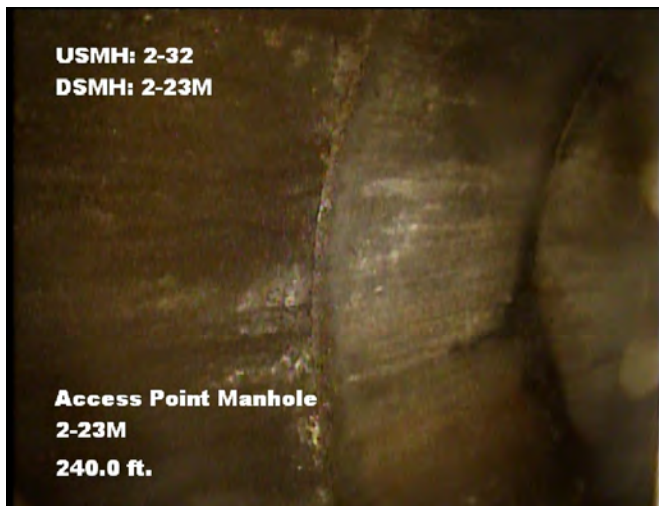
Distance: 240.0 ft. Grade: 0
Condition: Access Point Manhole
Remarks: 2-23M

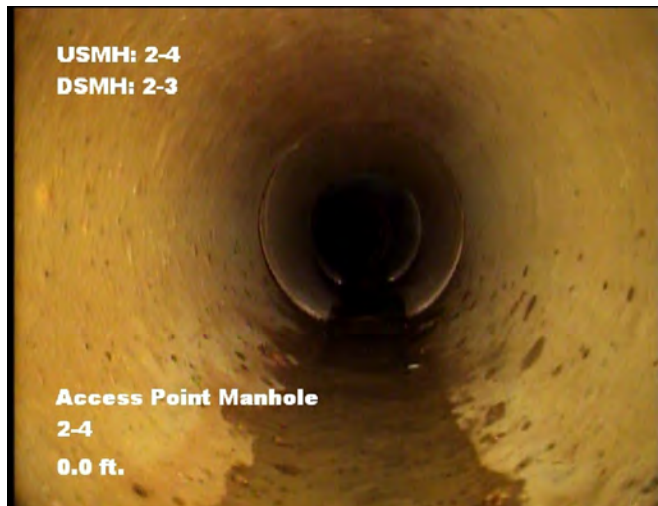
Distance: 0.0 ft. Grade: 0
Condition: Access Point Manhole
Remarks: 2-4

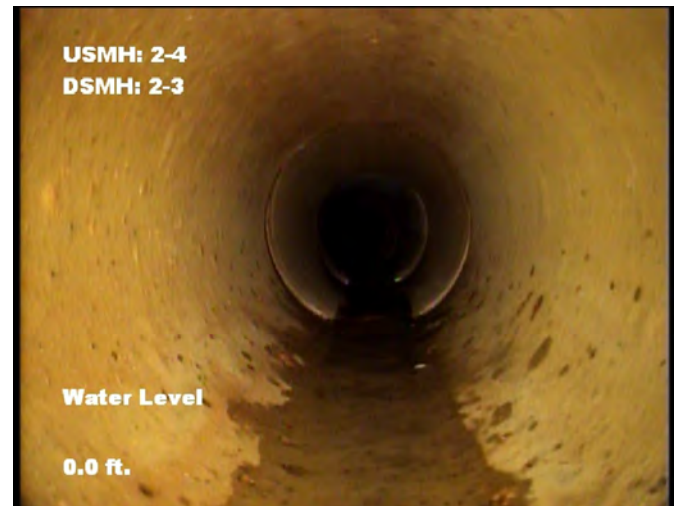
Distance: 0.0 ft. Grade: 0
Condition: Water Level
Remarks: N/A

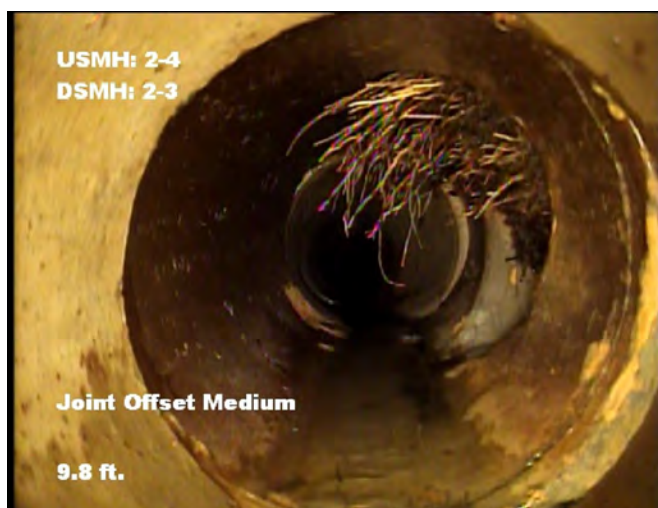
Distance: 9.8 ft. Grade: 1
Condition: Joint Offset Medium
Remarks: N/A

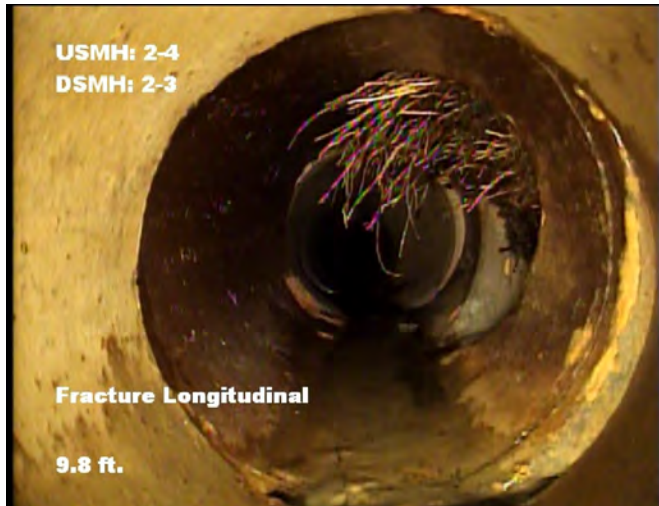
Distance: 9.8 ft. Grade: 3
Condition: Fracture Longitudinal
Remarks: N/A

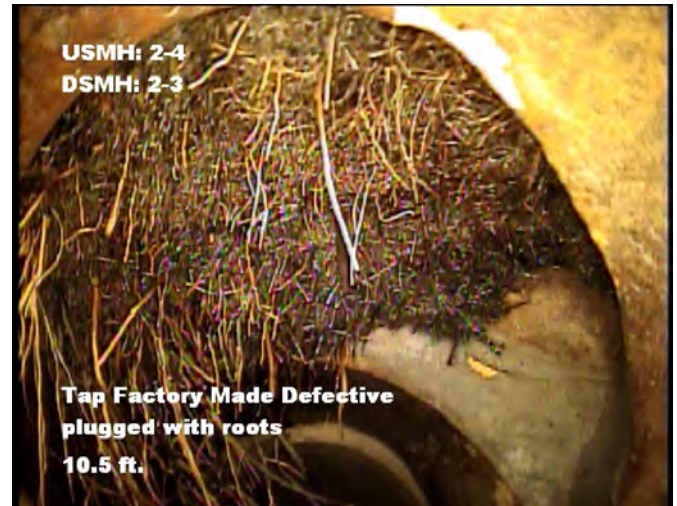
Distance: 10.5 ft. Grade: 2
Condition: Tap Factory Made Defective
Remarks: plugged with roots

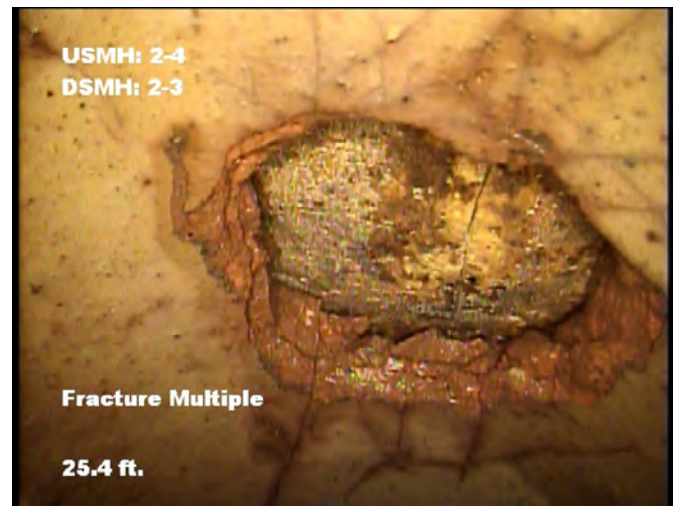
25.4 ft. Fracture Multiple

Distance: 25.4 ft. Grade: 4
Condition: Fracture Multiple
Remarks: N/A

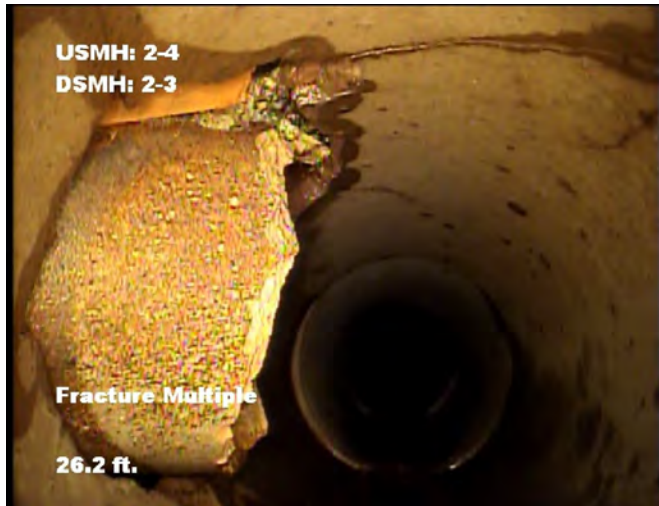
26.2 ft. Fracture Multiple

Distance: 26.2 ft. Grade: 4
Condition: Fracture Multiple
Remarks: N/A

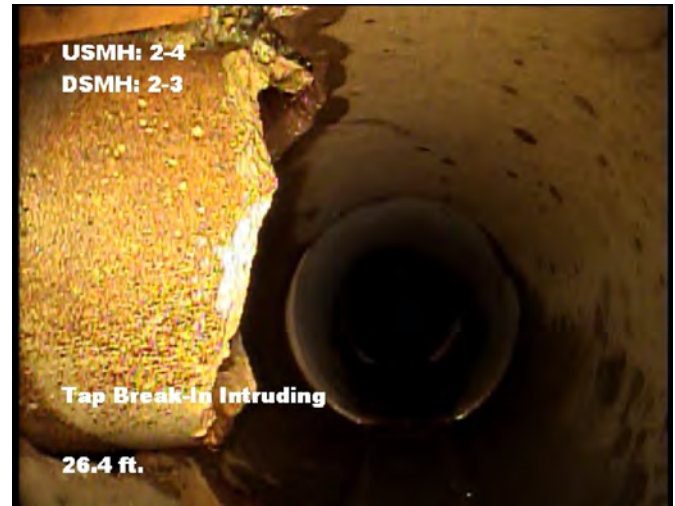
Distance: 26.4 ft. Grade: 2
Condition: Tap Break-In Intruding
Remarks: N/A

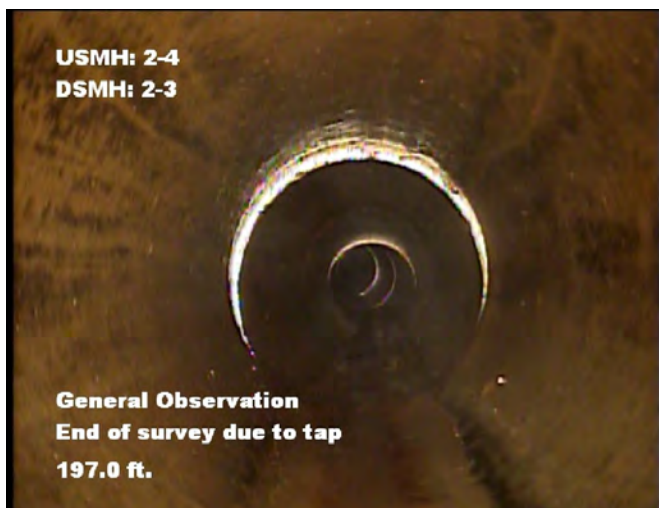
Distance: 197.0 ft. Grade: 0
Condition: General Observation
Remarks: End of survey due to tap

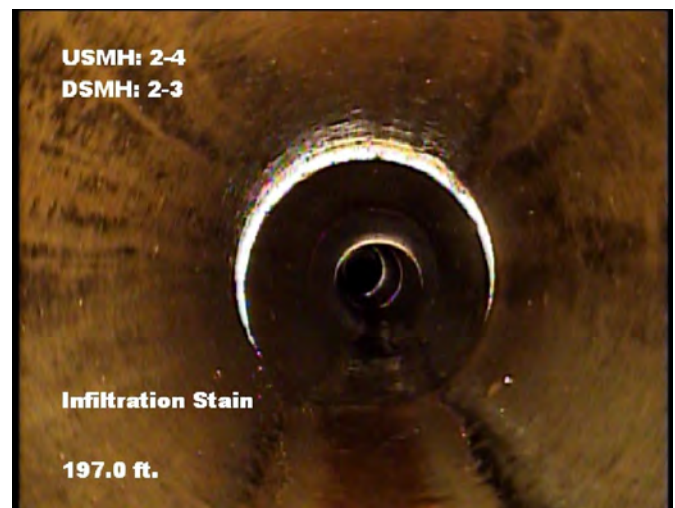
Distance: 197.0 ft. Grade: 0
Condition: Infiltration Stain
Remarks: N/A

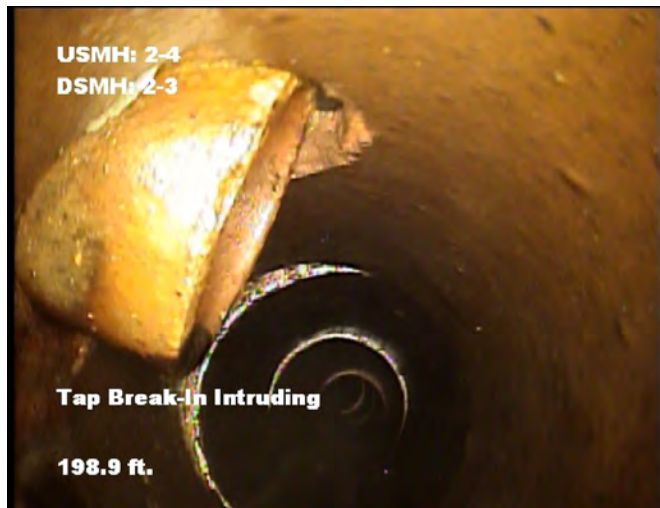
Distance: 198.9 ft. Grade: 2
Condition: Tap Break-In Intruding
Remarks: N/A

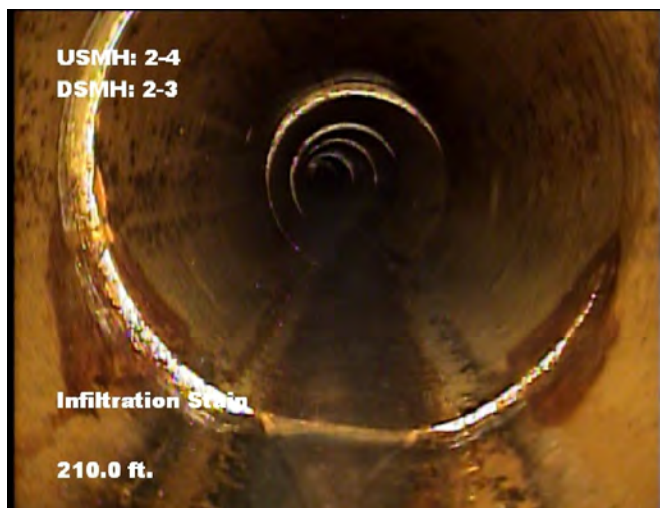
Distance: 216.0 ft. Grade: 0
Condition: Infiltration Stain
Remarks: N/A

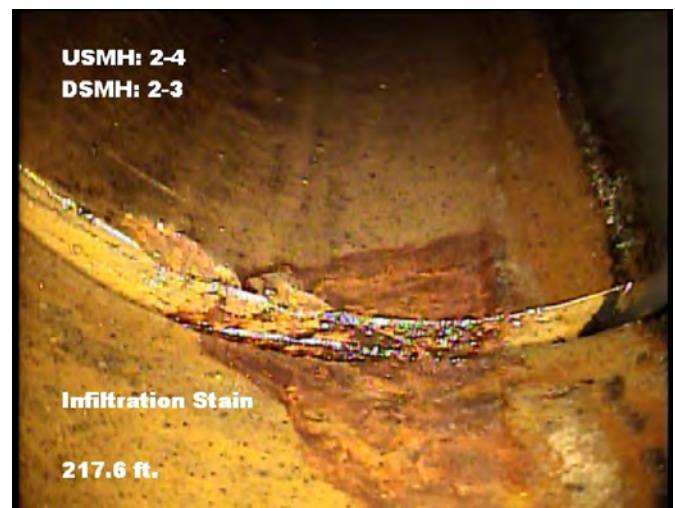
Distance: 217.6 ft. Grade: 0
Condition: Infiltration Stain
Remarks: N/A

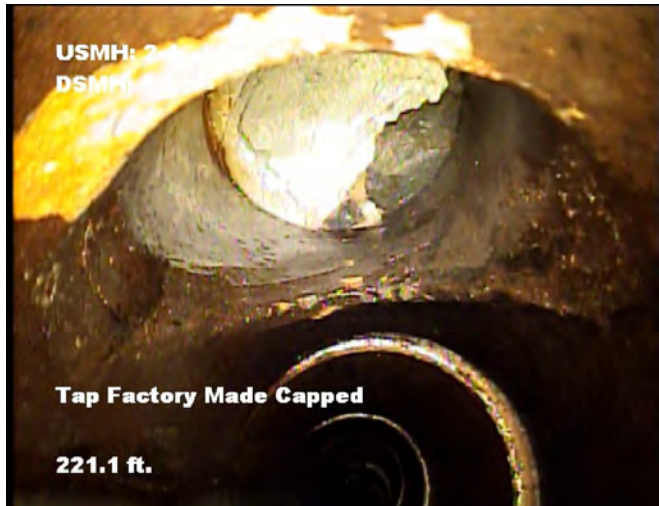
Distance: 221.1 ft. Grade: 0
Condition: Tap Factory Made Capped
Remarks: N/A

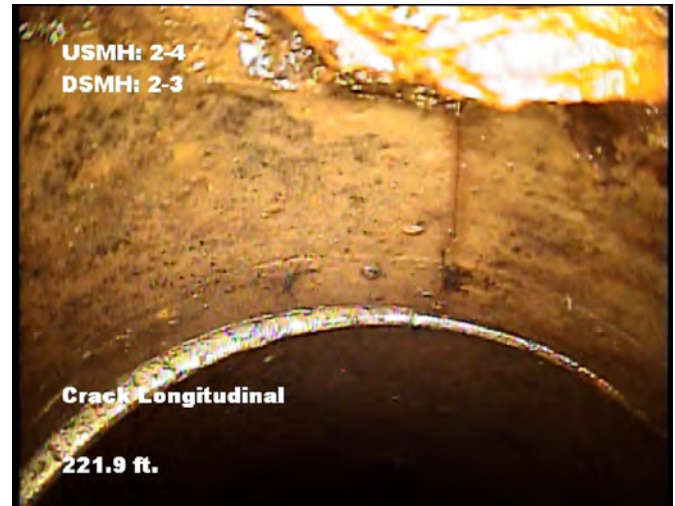
221.9 ft. Crack Longitudinal

Distance: 221.9 ft. Grade: 2
Condition: Crack Longitudinal
Remarks: N/A

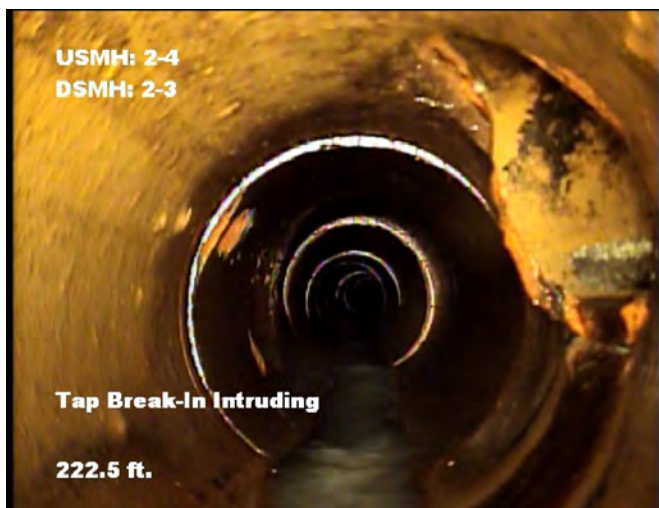
Distance: 222.5 ft. Grade: 2
Condition: Tap Break-In Intruding
Remarks: N/A

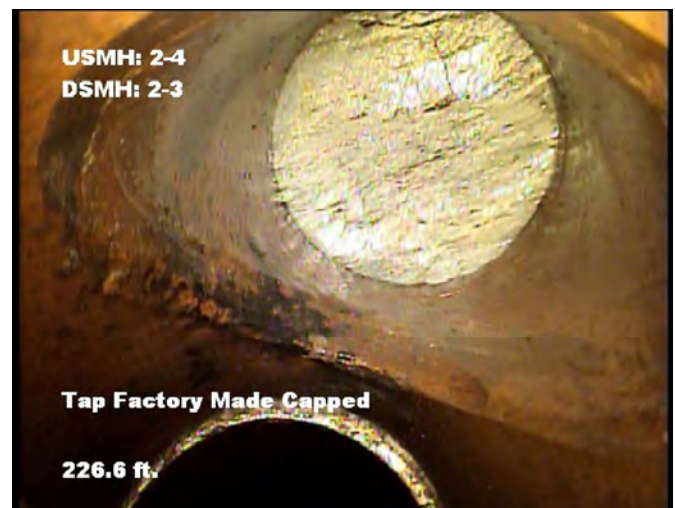
Distance: 226.6 ft. Grade: 0
Condition: Tap Factory Made Capped
Remarks: N/A

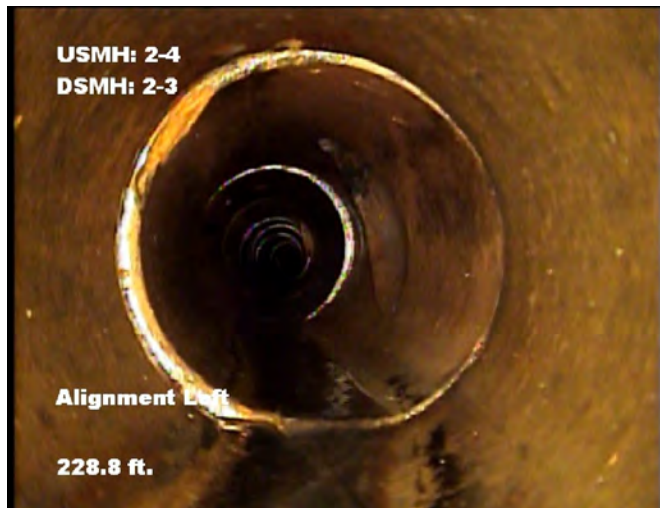
Distance: 228.8 ft. Grade: 2
Condition: Alignment Left
Remarks: N/A

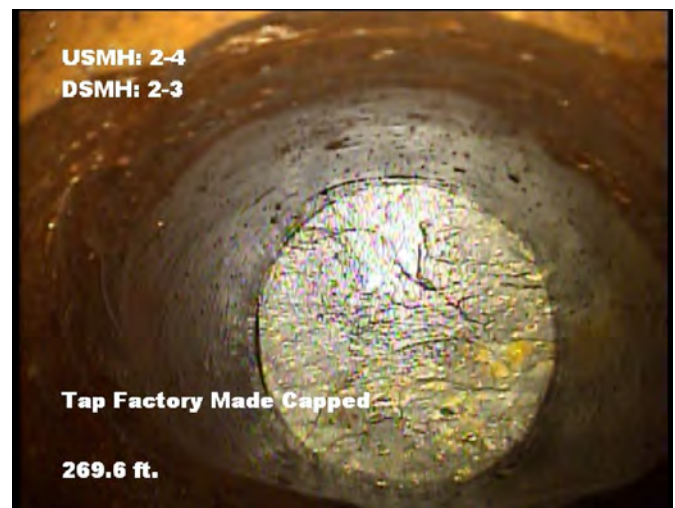
Distance: 269.6 ft. Grade: 0
Condition: Tap Factory Made Capped
Remarks: N/A

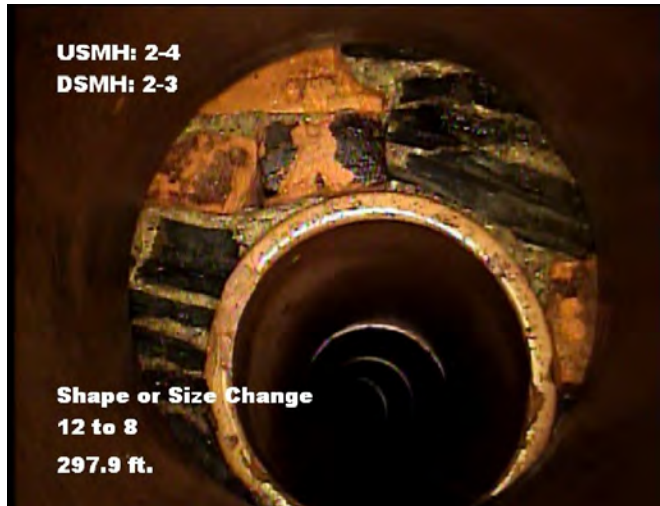
Distance: 297.9 ft. Grade: 0
Condition: Shape or Size Change
Remarks: 12 to 8

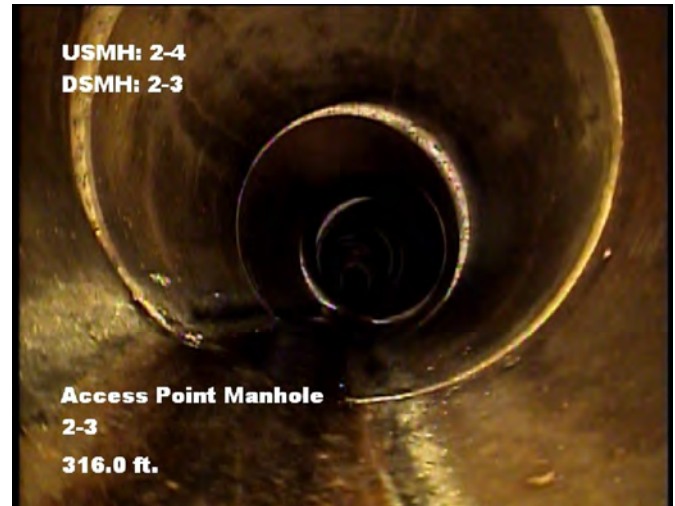
Distance: 316.0 ft. Grade: 0
Condition: Access Point Manhole
Remarks: 2-3
